**UNITED STATES DISTRICT COURT  
NORTHERN DISTRICT OF CALIFORNIA**

CHART INC.

Case No. 3:20-cv-4996

**COMPLAINT AND  
DEMAND FOR JURY TRIAL**

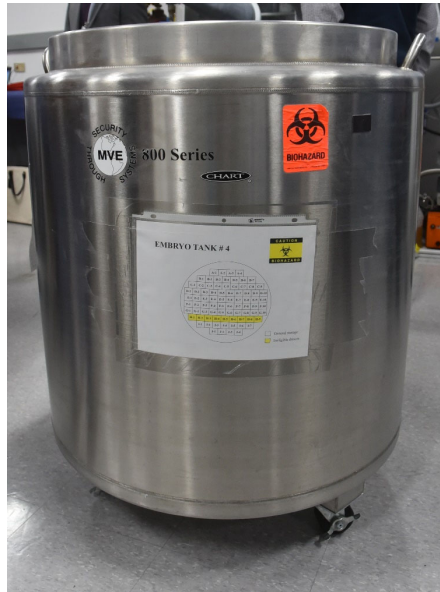
*Tank 4*

1           15.     The tank at issue in this litigation is an MVE-branded cryopreservation tank—  
2 specifically, a model MVE 808AF-GB Stainless Steel Freezer, which the embryologists at the Pacific  
3 Fertility Center referred to as Tank 4:

15           16.     The tank consists of the outer vessel seen above, an inner vessel that can be used to store  
16 eggs and embryos in liquid nitrogen, and an insulated vacuum layer that separates the two vessels and  
17 prevents heat transfer from the surrounding environment.
